NASA TN D-3068

EVALUATION OF A SUBSCALE INTERNALLY INSULATED FIBER-GLASS PROPELLANT TANK FOR LIQUID HYDROGEN

by Laurence J. Heidelberg Lewis Research Center Cleveland, Ohio

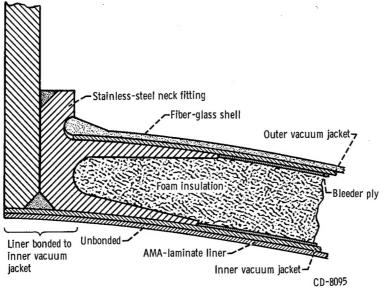
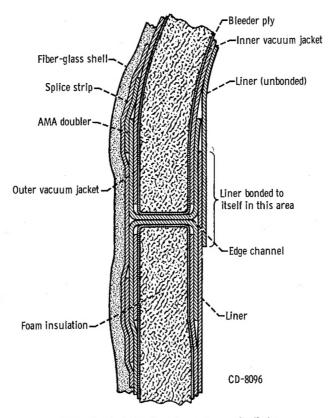
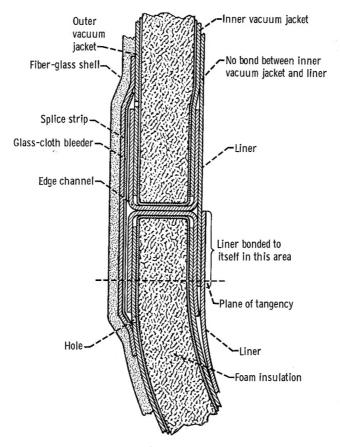
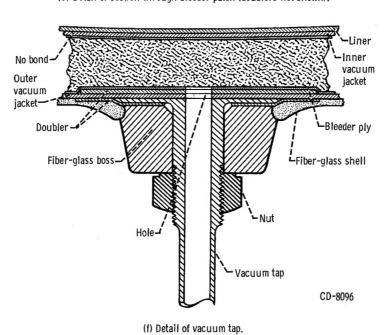
Figure 1. - Details of filament-wound liquid-hydrogen test tank. All surfaces bonded except as indicated. (Not to scale.)

As shown in figures 14, 15, and 16, there is a large heat short at the intersection of the bottom dome and the cylindrical section of the insulation. This heat short is caused by the heavy AMA laminate used on the edge of each insulation section (see fig. 1(d), p. 5). The heat short was calculated to be 1050 Btu per hour, while the value, determined by extrapolating the curve (see figs. 14 to 16) and assuming the heat flux through the bottom dome the same as in the cylindrical section, varied from 1000 to 1340 Btu per hour, depending on ambient conditions. At 75 percent of tank capacity more than 50 percent of the heat transfer was due to this heat short. Calculations show that if Mylar were used instead of the AMA laminate to seal the edges of the insulation sections, the heat short to the liquid would be reduced to approximately 1 Btu per hour.

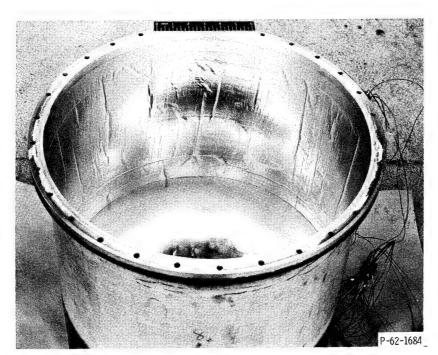
Figure 10. – Uninsulated filament-wound tank with test liner wrinkles after two temperature and pressure cycles.

Prior to fabrication of the test tank, uninsulated but lined filament-wound tanks, similar in geometry to the test tank, were pressure cycled with liquid hydrogen in a vacuum chamber to check the reliability of the adhesive joints with respect to maintaining a seal. The liner shown in figure 10 has gone through two temperature and pressure cycles. After some initial failures a reliable leak-tight adhesive bond was achieved. However, it was decided that some method of reducing the size of the wrinkles in the liner must be found or the resulting sharp creases formed upon repressurization would cause leaks or even breaks. If the liner material is stressed beyond its elastic limit, subsequent loadings to a lower stress produce no further permanent set. be seen in figure 8 where the AMA laminate was first stressed to 8300 pounds per square inch and then cycled from 0 to 6250 pounds per square inch six times. It was decided to fabricate the liner and vacuum jackets from 25-pound-per-inchload (10 040 psi) prestretched AMA laminate to keep the permanent set and, therefore, the wrinkles to a minimum. Figure 9 shows a cycling test of this prestretched material at a temperature of -300° F and a strain of 0.015 inch per inch. It should be noted that most of the strain is within the elastic range. Even with this prestressed material some permanent set was expected when it was used in the test tank. But, it was felt that the bond between the foam insulation and the inner vacuum jacket would stabilize the wrinkles that would occur thus preventing the formation of sharp creases.

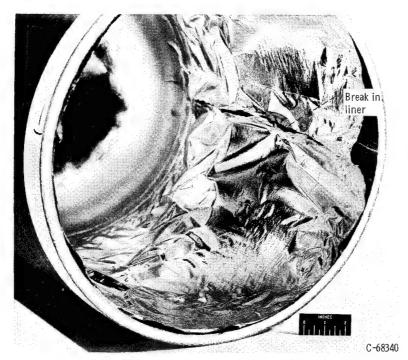
Figure 17. - Inside of tank (showing failure in liner).

Liner failure occurred suddenly with a longitudinal break in the cylindrical section of the tank (see fig. 17). Figure 18 shows the brittle fracture of the Mylar in the liner. Both the liner and the inner vacuum jacket failed at the same place. It should be noted that, even though the liner was highly stressed, all adhesive joints remained leak-tight. Upon examination of the inner vacuum jacket it was discovered that the break occurred along the butt joint of the glass-cloth bleeder ply (see fig. 19). Since the glass-cloth reinforced the vacuum jacket everywhere but at the butt joint where the cloth ends were not spliced, this was the area of highest stress. Instead of the inner vacuum jacket uniformly straining along the entire circumference, most of the expansion occurred over the very small length of this maximum stress area. Thus, the local unit strain was many times higher than it would have been for a uniformly strained material. It is probably the vacuum-jacket failure that initiated the failure in the liner at the same location. It is possible that this failure could have been prevented if the ends of the glass cloth were spliced at the butt joint with a bonded glass-cloth tape.

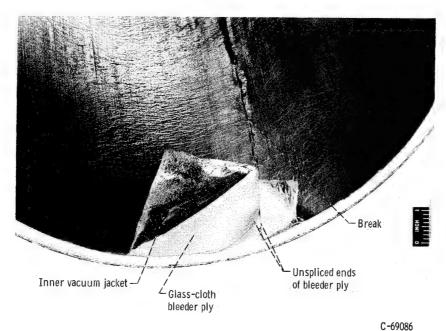
Figure 19. - Failure in inner vacuum jacket (liner removed from tank).

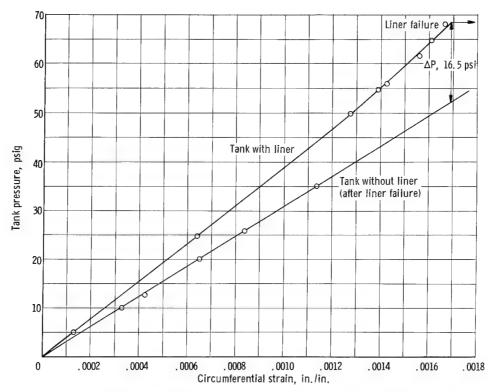
Figure 20. - Effect of liner failure on circumferential strain of tank wall.

The circumferential strain of the fiber-glass shell was measured during pressure tests of this tank both before and after liner failure. Figure 20 shows a plot of this strain against internal tank pressure. When failure occurred at 68.4 pounds per square inch gage, the release of the load carried by the liner and vacuum jacket resulted in increased load on a corresponding strain in the fiber-glass shell. Since the strain at failure, 0.0017 inch per inch, results from a load of only 51.9 pounds per square inch gage after failure, the difference between 68.4 and 51.9 pounds per square inch gage was assumed to be the load the liner and vacuum jacket were taking. Thus, the liner and jacket were taking an internal pressure load of 16.5 pounds per square inch and correspondingly stressed to 29 000 pounds per square inch at failure. This is an increase in tensile strength from the 25 000 pounds per square inch at -300° F listed in table I. The 51.9 pounds per square inch gage carried by the fiberglass shell results in a composite wall stress of 12 000 pounds per square inch, well below its ultimate of 120 000 pounds per square inch.

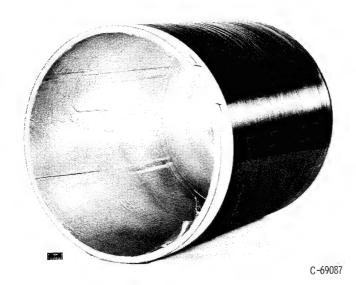
Final examination of the tank revealed the existance of wrinkles indicating the liner and inner vacuum jacket material has been stressed beyond its elastic limit and thus has taken a permanent set in spite of prestressing the AMA laminate. It was found that the wrinkles in the vacuum jacket (see fig. 21) are not sharply creased as in the preliminary liner tests but rather they are rounded and not likely to be leak sources. It appears that the glass cloth and foam help stabilize the wrinkles and prevent the formation of sharp creases.

Figure 21. - Inner vacuum jacket after testing.
